## **CHAPTER 4**

### **WATERSHED AND FLOODPLAIN CHARACTERISTICS**

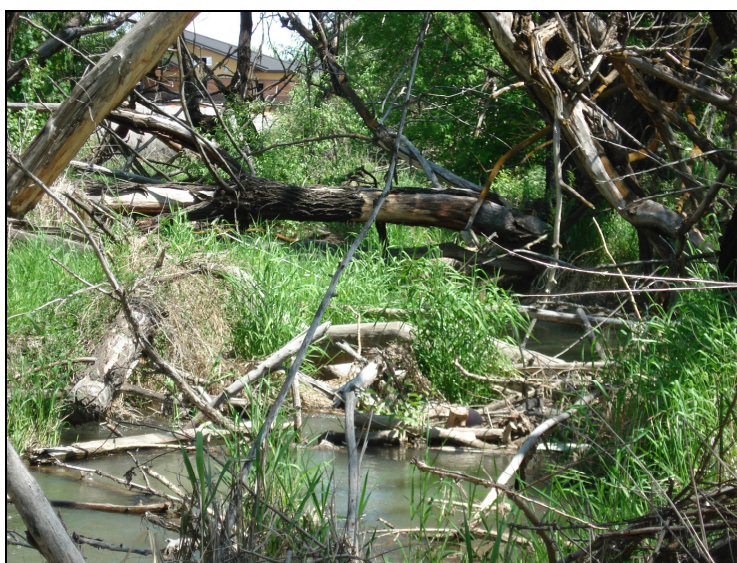
*Figure 4-14 Effects to channels due to hybrid willows.*

These non-native plant communities can have a dramatic impact on channel shape and function over time – reducing flood conveyance, changing the nature of the channel substrate (more fines material and organics) and increasing channel roughness so that overbank flooding increases in frequency. This is a special concern in this watershed since it is composed of flat or undulating floodplains which can route shallow floodwaters across relatively large areas of the floodplain. The alteration of the basin since 1947 can be seen on Figure 4-16. The impact on channel roughness thereby increasing flood levels can be seen from Figure 4-17, which was assembled to support the FEMA flood mapping restudy. Example of channel constriction is shown in Figure 4-14. Effect on structure in Figure 4-15.

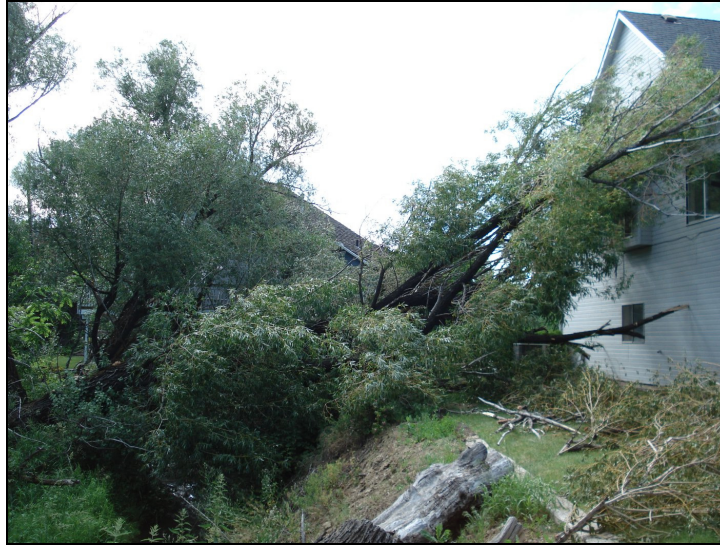
*Figure 4-15 Effects to structures due to hybrid willows.*

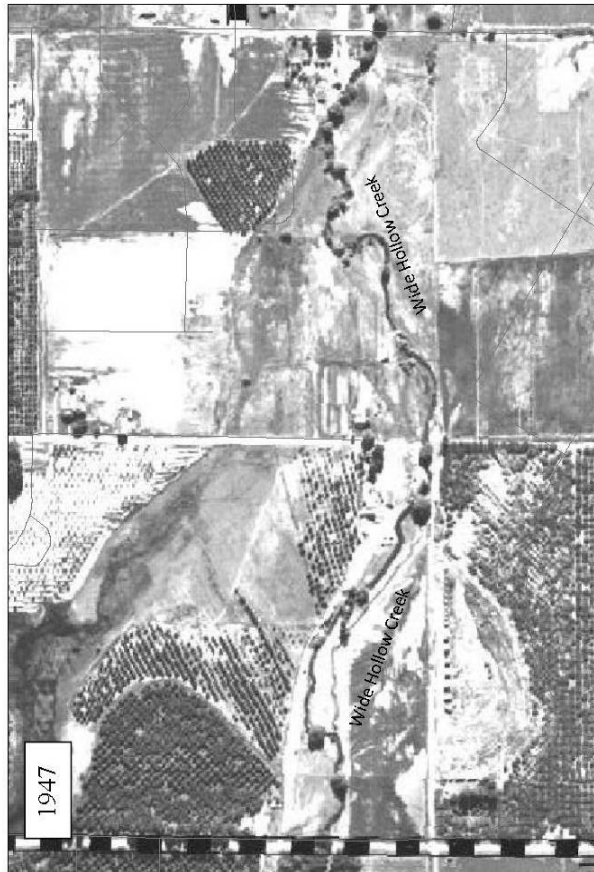
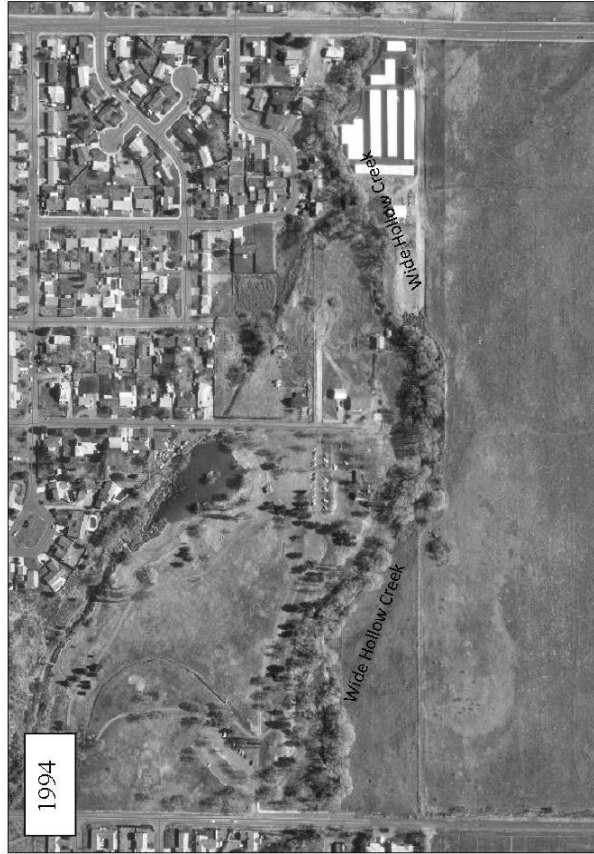
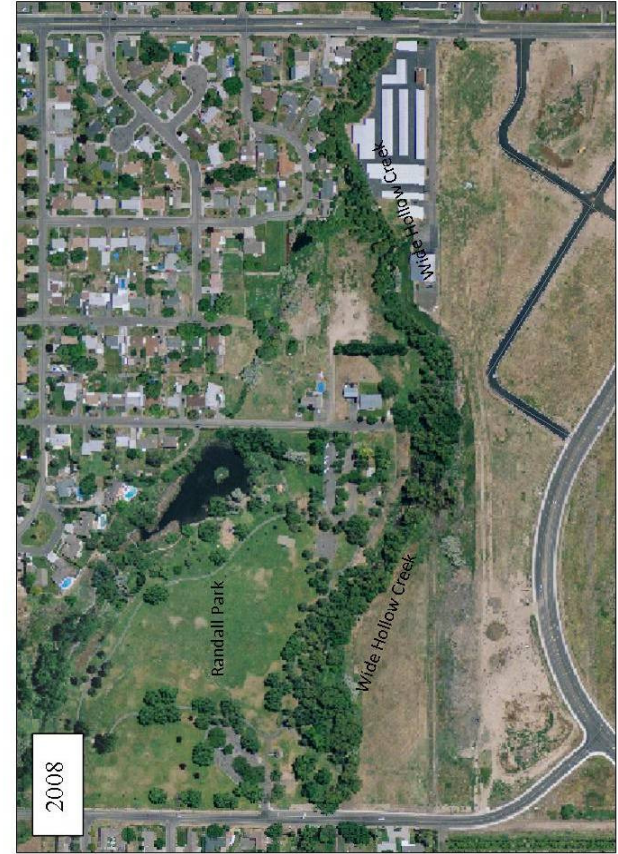
Figure 4-16

An example of the progression of willows.
