CHAPTER 7

BASIN FLOODING CHARACTERISTICS

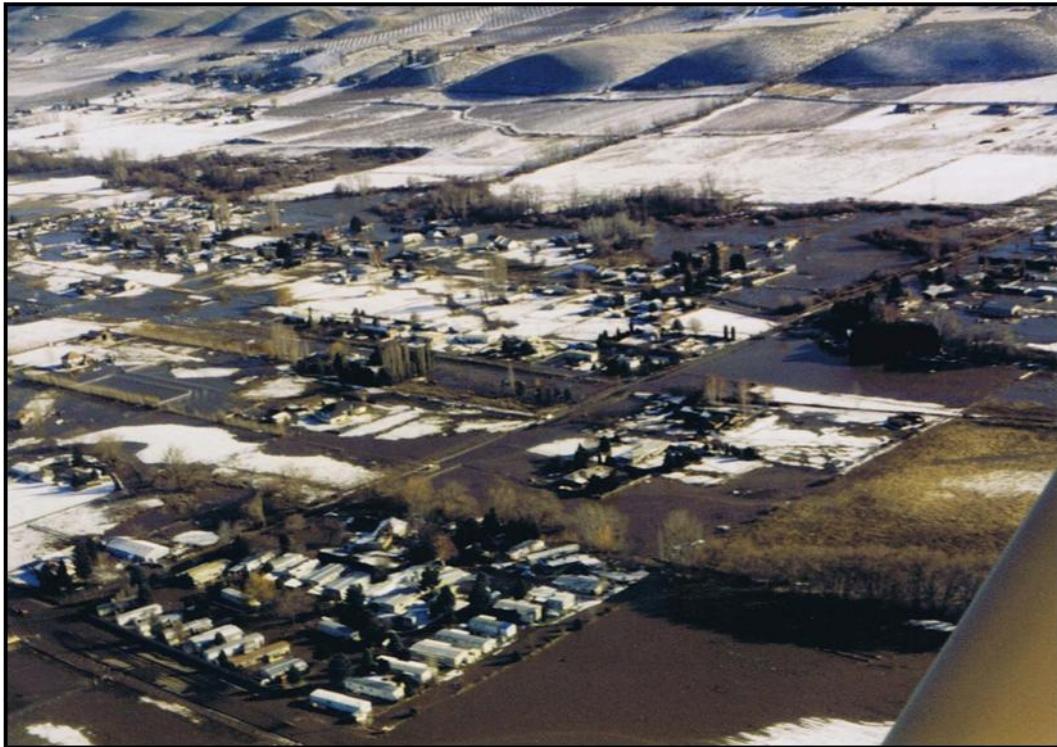
Figure 7-2

1996 Ahtanum Flooding

Emma Lane & 42nd – looking Southeast

Arial photographs of the 1996 flood are shown in Figures 7-2 and 7-3

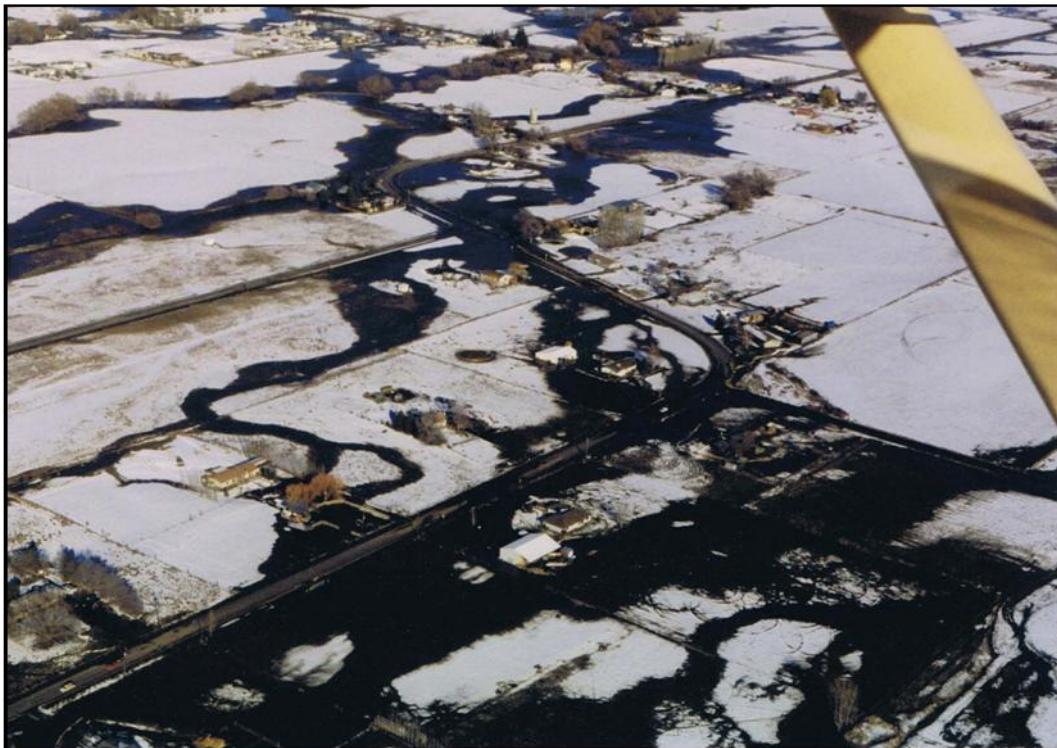
Rutherford Road – looking Northeast

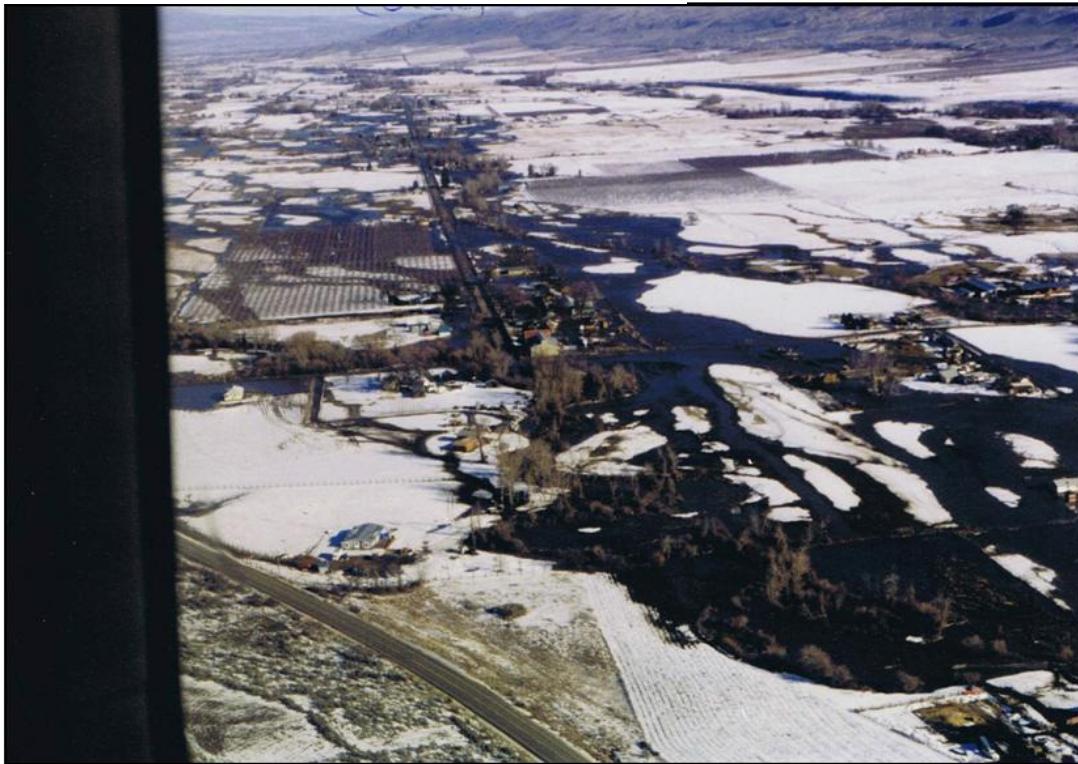
Figure 7-3

1996 Ahtanum Flooding

Community of Ahtanum- looking East

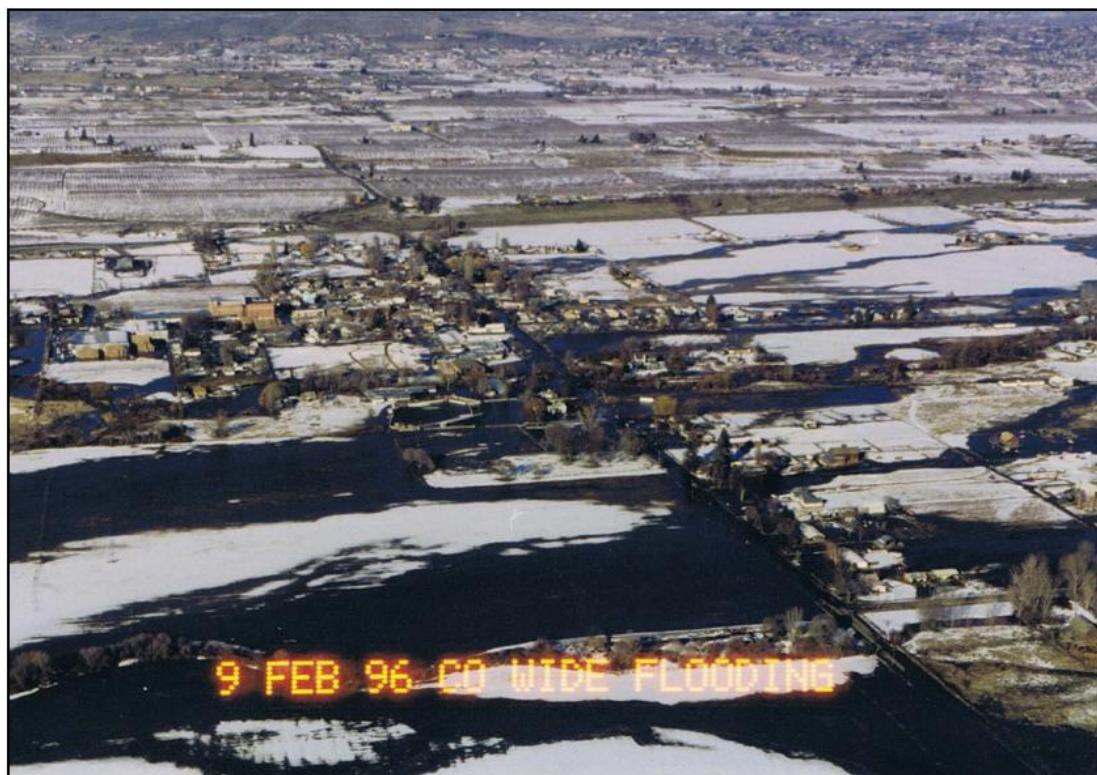
Wiley City – looking North

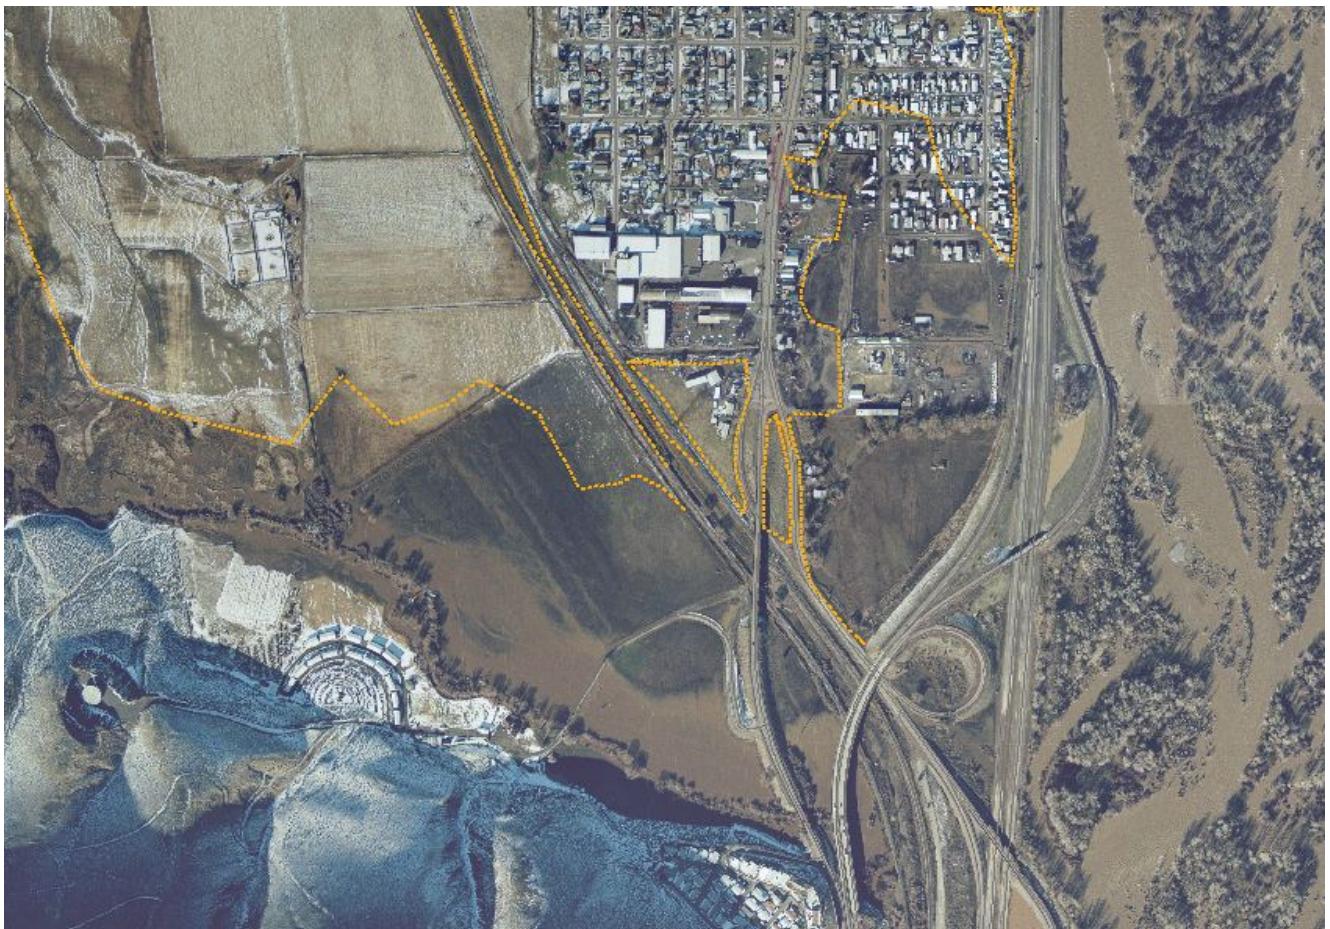
Figure 7-4 1996 Flood Extent in Union Gap

Unlike the remainder of the watershed, Spring Creek (Chambers) East is a side channel of the Yakima River. When the Yakima River is in flood, floodwaters travel upstream into Lower Spring Creek (Chambers), Wide Hollow, and during large events, Ahtanum Creek. LiDAR data and other information sources indicate that the bed of the Yakima River is rising in this reach, which in turn, should cause flood levels in the river and in these backwater areas, and the local groundwater table, to rise as well. Recent studies by WSDOT for the Valley Mall Boulevard exit also indicate that flood levels have risen since the original flood studies from the early 1970s. If the bed of the Yakima River continues to rise, the potential exists for the freeway to be overtopped, which would bring a large area of the City

of Union Gap into the floodplain, or at much higher flood risk than currently on the Flood Insurance Rate Panels. See Figure 7-4.

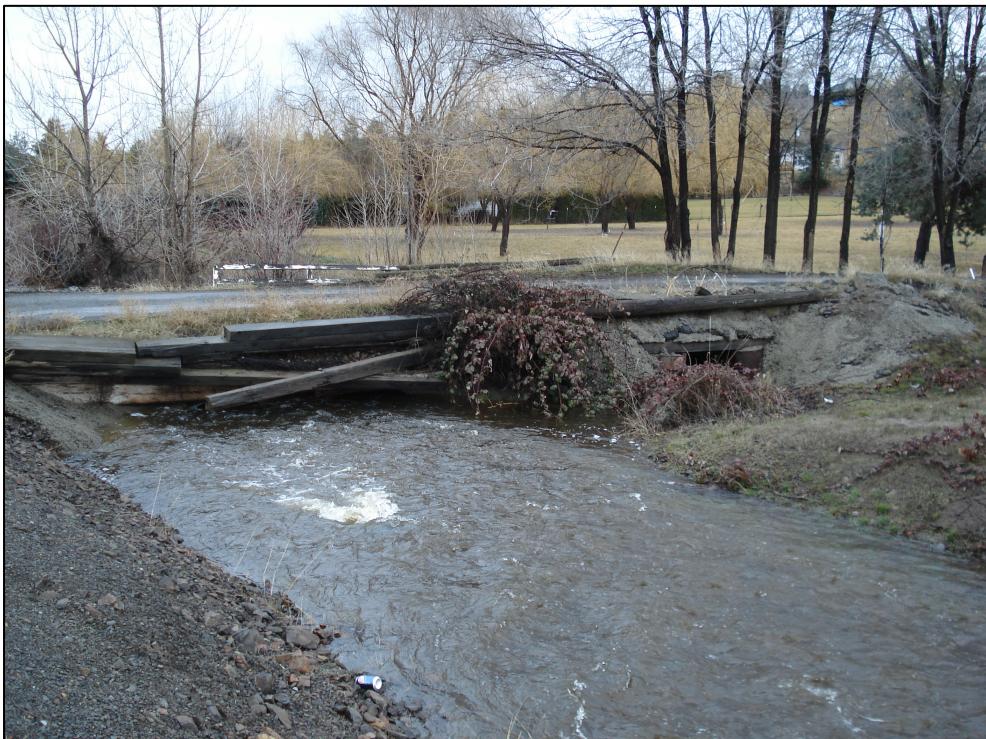
Figure 7-5 Example of a bridge constriction - Cottonwood Creek

Historically, due to the flat floodplains bridges were built to span the active channel, resulting in under-sizing of the bridges to pass flood flows and causing sediment accumulations in the channels upstream of bridges. Private parties and public agencies found it necessary to periodically “clean out” the bridge approaches to maintain conveyance capacity for annual flood events. With the increasing regulation of activities in stream channels, this maintenance activity has decreased for both public and private bridges. This

in turn results in more frequent out of bank flooding associated with bridge crossings, especially the larger public bridges. In addition, the FEMA remapping has shown that the improvement of arterial roads with large amounts of fill, when orientated east-west parallel to the streams, has blocked the north south alignment of historic flow paths and redirected flows onto previously unaffected land.

The large amount of vegetation, noted in Chapter 4, contributes to reduced channel conveyance at the bridges and within their approaches further exacerbating the crossing flood issue.
